**OPEN SPACE ADVISORY COMMITTEE
STAFF REPORT**

REQUEST: For possible action to: recommend to the Board of Supervisors acceptance of the monitoring report for the Horsecreek Ranch Conservation Easement for 2011.

Carson City Open Space – Conservation Easement Monitoring

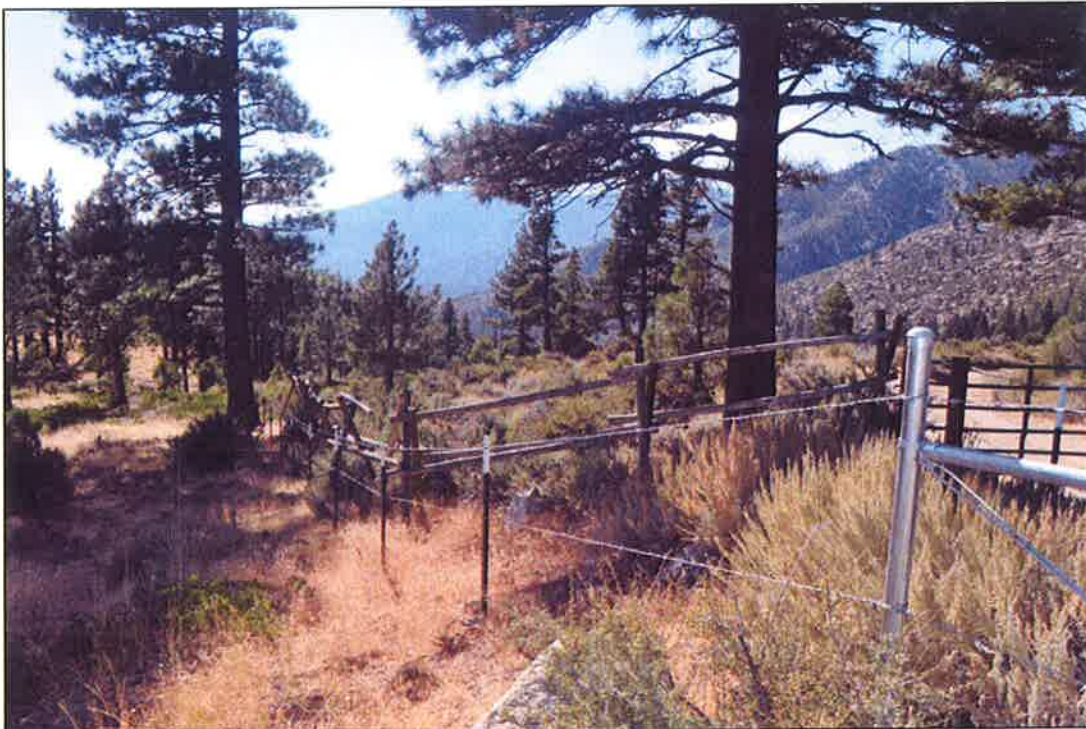
Photo – At the upper gated entrance, a new three-strand barbed wire fence extends to the south.

The fence installation along the east property line, as discussed above, is not constrained by the fencing restrictions identified for specific areas of the property.
