**OPEN SPACE ADVISORY COMMITTEE  
STAFF REPORT**

**REQUEST:** For possible action to: recommend to the Board of Supervisors acceptance of the monitoring report for the Horsecreek Ranch Conservation Easement for 2011.

## Carson City Open Space – Conservation Easement Monitoring

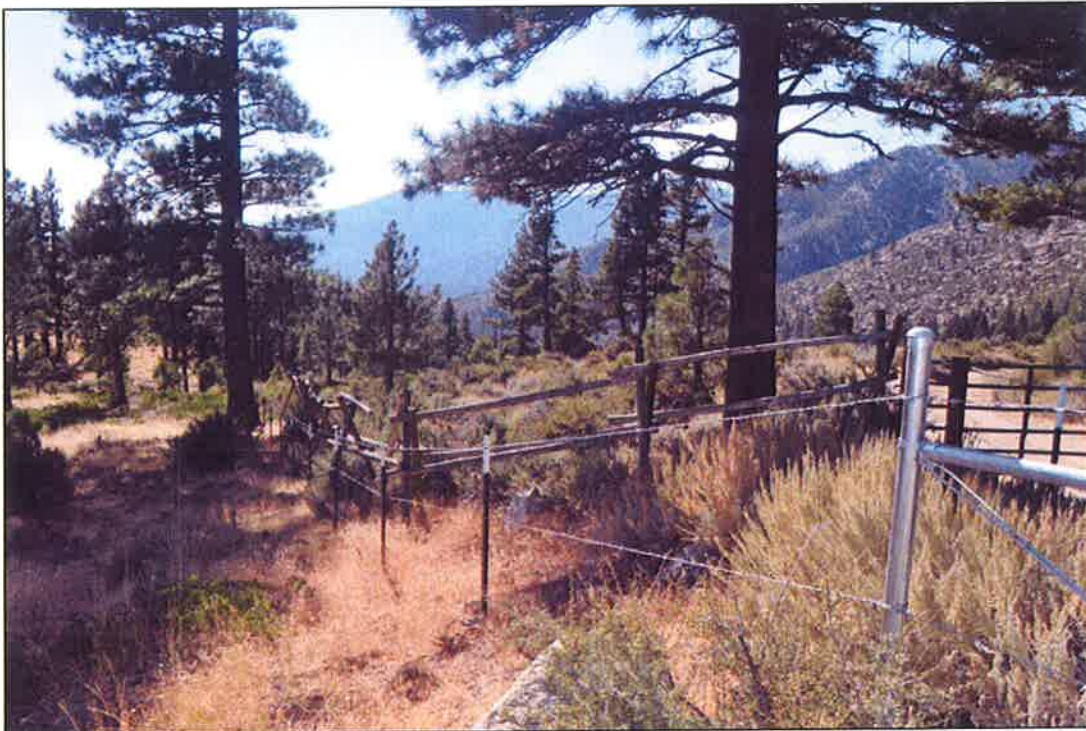
Photo – At the upper gated entrance, a new three-strand barbed wire fence extends to the south.

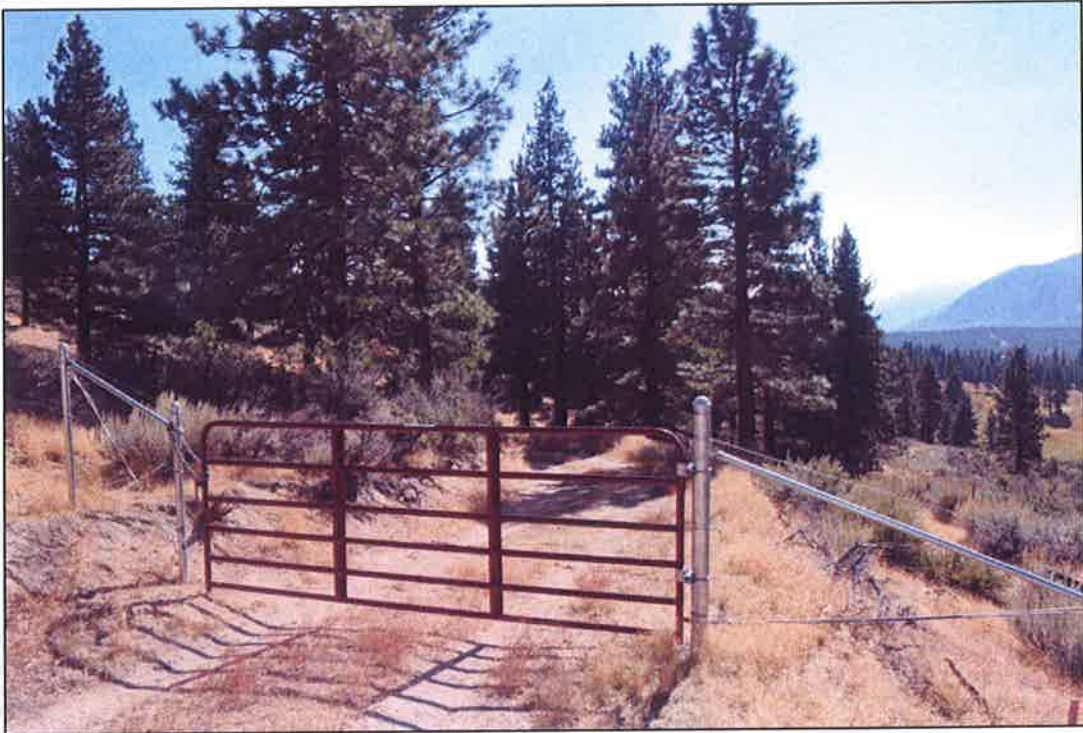
Photo: At the southeast property corner with the USFS, a new gate was installed to control access.

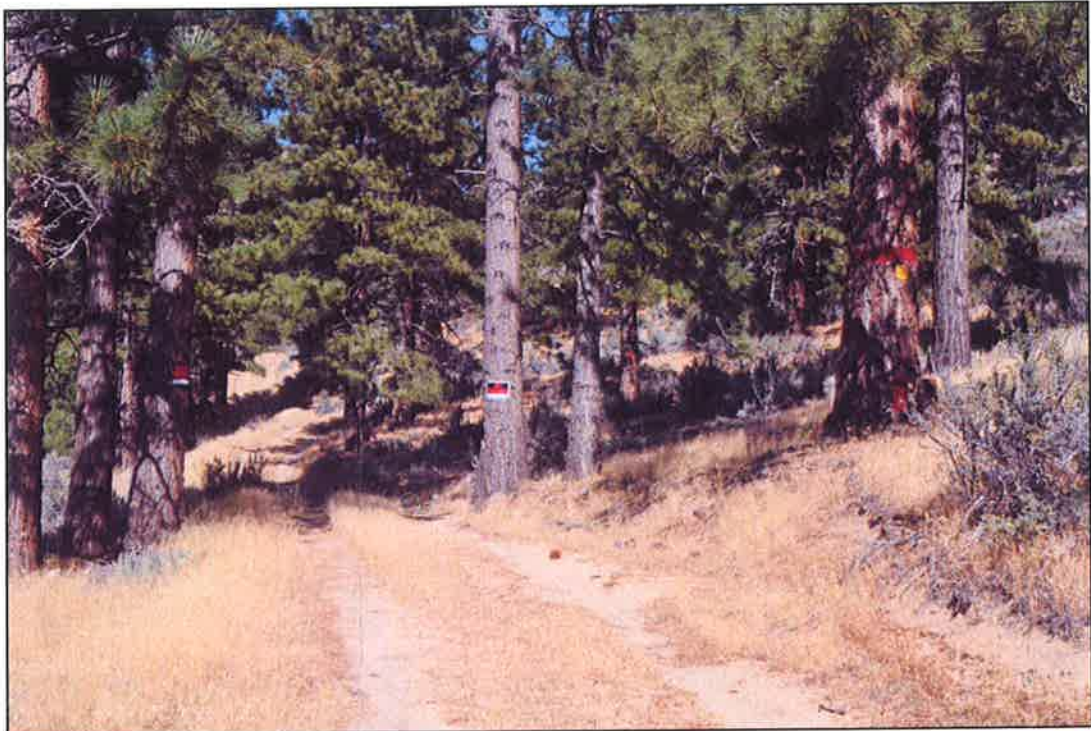
Photo: At the southeast property corner with the USFS, private property and no trespassing signs were posted.

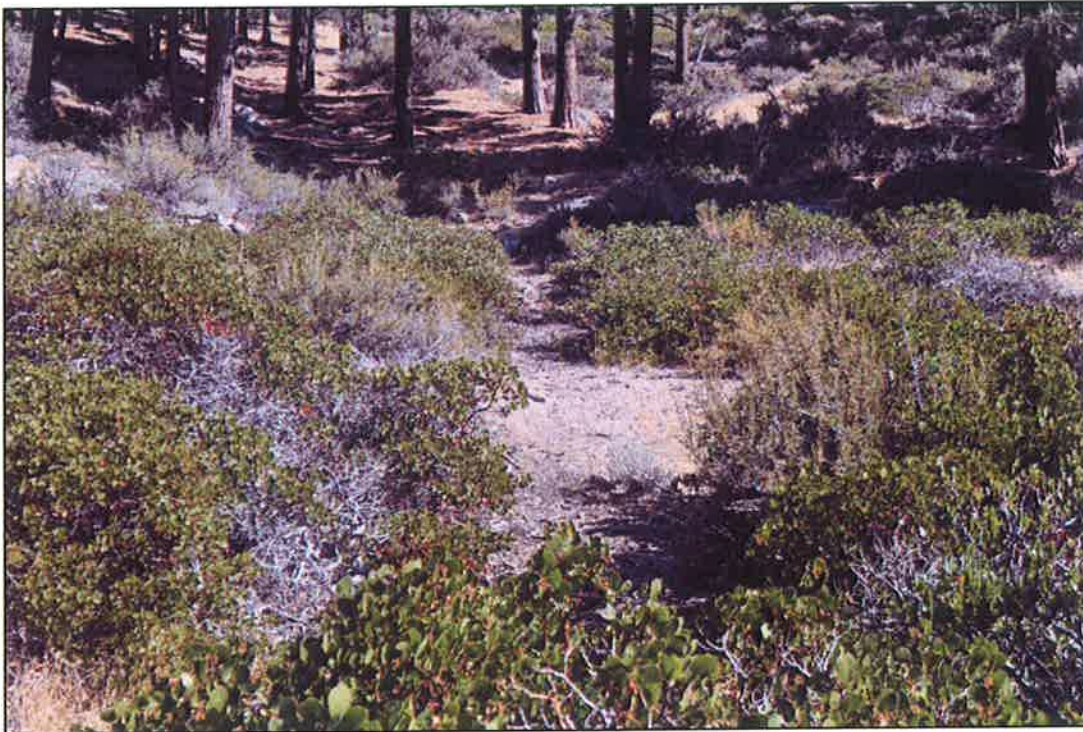
N 39° 08' 11.4" W 119° 50' 09.9"

The previous report mentioned a few areas of trespass and the off-road tracks caused by dirt bike use. Since installation of the gate and barbed wire fence, the trespass and unauthorized vehicle use have dissipated.

Photo: The previously photographed dirt bike tracks were not apparent. View from the conservation easement uphill to the adjacent USFS lands on the east.

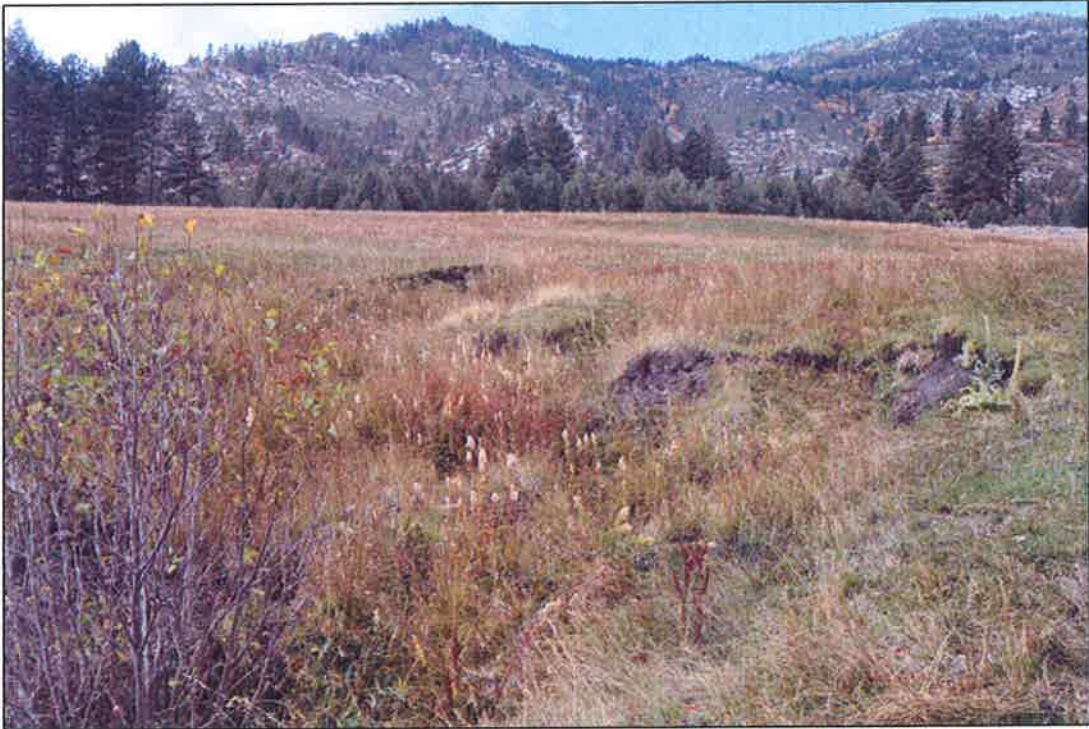
The following is an update and continued monitoring as referenced in the previous report: According to the Mr. Fagen, there was significant winter and spring runoff in the drainage located east of the cabins. Generally, the field conditions appear stable from last year and the vegetation seems to be establishing. Likewise for the lower meadow located south of the cabins. A few areas such as the headcut identified in Photos 4A – 4C should receive some stabilization work though, and Carson City will work with Mr. Fagen towards this goal.

Photo: The photo of this drainage, located south of the cabins, has been included to document current condition and vegetation growth. N 39 07' 42.7" W 119 50' 10.2"

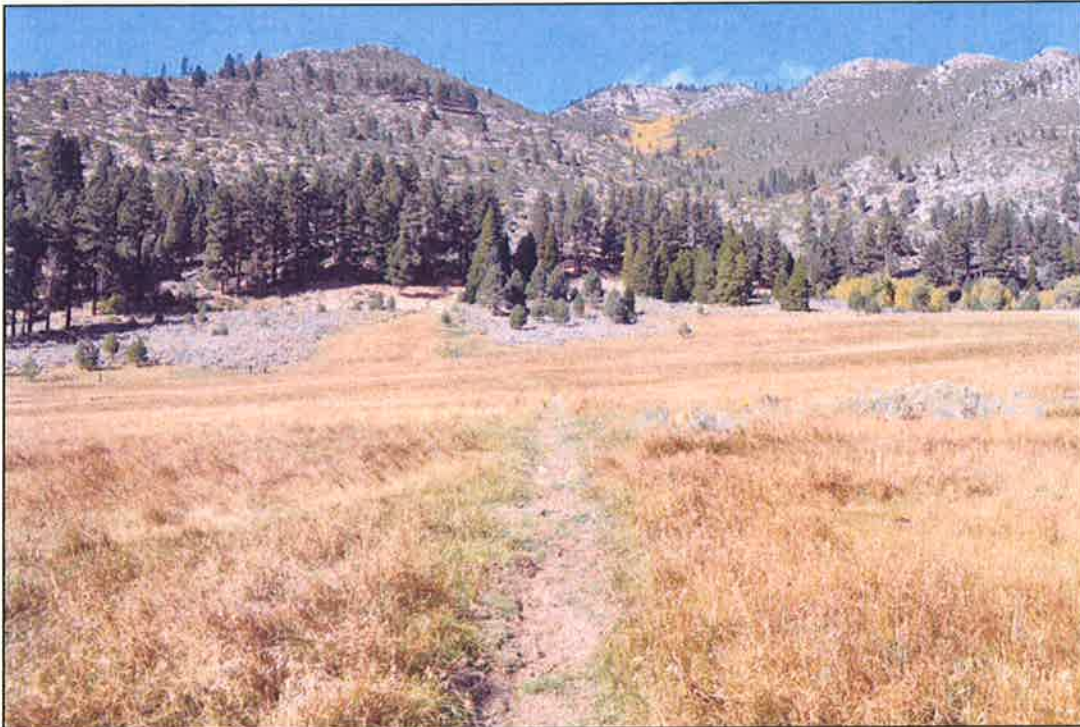
The previous report recommended monitoring for revegetation along the excavated pipeline area. During this field monitoring visit, preferred grass and forb species were not yet apparent. Rather, annual weeds such as cheatgrass and redstem filaree were most common. If natural revegetation is not successful within a few years, a mix of meadow grasses may need to be purchased and raked into the soil during the late fall months.

Photo: The photo of the pipeline excavation area has been included to document current condition and vegetation growth.
